# Differential draft the bottoms of vertical reservoirs, operating in Arctic conditions

A.A. Alexeev, A. M. Bolshakov, N.K.Malarov

Larionov Institute of the Physical-Technical Problems of the North of the Siberian Branch of Russian Academy of Sciences  
677891, Russian Federation, Yakutsk, 1, Oktyabrskaya str.  
[spinor03@gmail.com](mailto:spinor03@gmail.com)

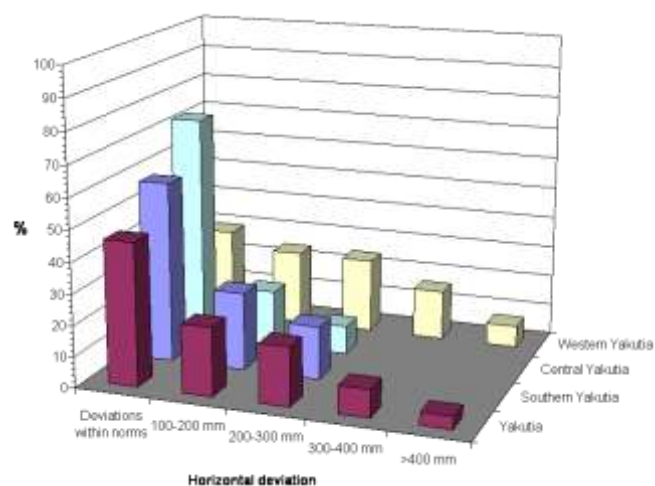
Figure 1. Draft of reservoirs.

According to analysis, found (Figure 1):

*On the territory of Yakutia:* deviation reservoirs horizontally within norms - 46%, deviation reservoirs horizontally above rules - 54%, including deviation from 100 to 200 mm - 22%,

from 200 to 300 mm - 19%, by 300 to 400 mm - 9% or more than 400 mm - 4%;

*On the territory of Southern Yakutia:* deviation reservoirs horizontally within the rules - 58%, deviation reservoirs horizontally above rules - 42%, including deviation from 100 to 200 mm - 25%, from 200 to 300 mm - 17%;

*On the territory of Central Yakutia:* deviation reservoirs horizontally within the rules - 73 %, deviation reservoirs horizontally above rules - 27%, including deviation from 100 to 200 mm - 18%, from 200 to 300 mm - 9%;

*On the territory of Western Yakutia:* deviation reservoirs horizontally within the rules - 29%, deviation reservoirs horizontally above the norm - 71%, including deviations from 100 to 200 mm - 24%, from 200 to 300 mm - 24 %, from 300 to 400 mm - 16% and more than 400 mm - 7%.

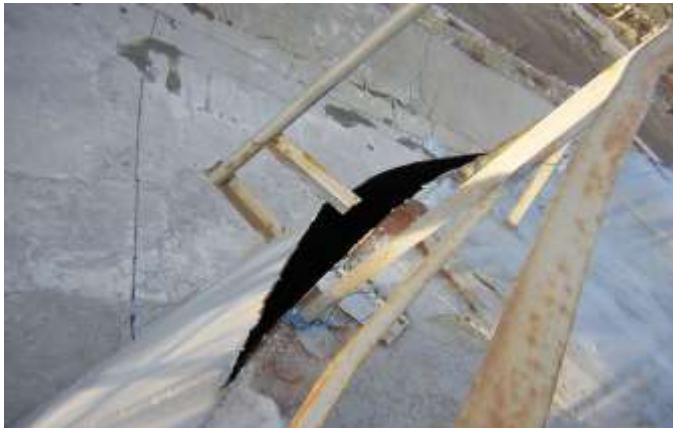
Figure 2. Wall of RVS-700.

These deviations have appeared in the course of operation are a greater threat of accident reservoir. Thus, in 2002-2003 years, there were 2 cases of accident RVS-700 due to differential draft bottom. The reservoirs were put into operation in the 1976-1982 years, the passport stamp steel - 09G2S. In the first case of an accident due to differential draft bottom of the reservoir RVS-700 was climbing central pillar of the reservoir which eventually led to the separation of the roof from the wall at the joints (Figure 2). This fracture occurred in sub-zero temperatures and filled reservoir, although not brought to the emergency filling fuel but has led to the exit of the exploitation of the reservoir.

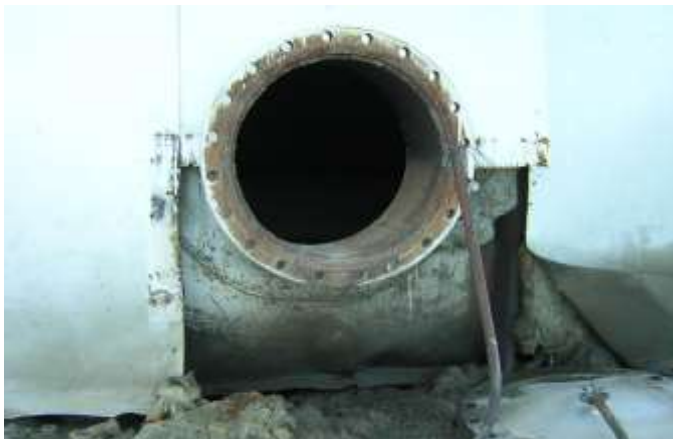
Figure 3. Wall deformation RVS-700.

In the second case, due to differential draft reservoir bottom RVS-700 occurred in the form of local deformation folds (buckling) of the wall at the junction of the bottom plates, which resulted in formation of the through hole (Figure 3). In this case, there was no emergency fuel filling was carry out the county and pumping the fuel, but the reservoir was also decommissioned.
